SERVICE BULLETIN

Model: Elise 'Mk.2'

Number:
2003/09
Issue 2

TITLE: Front turn indicator lamp retention.

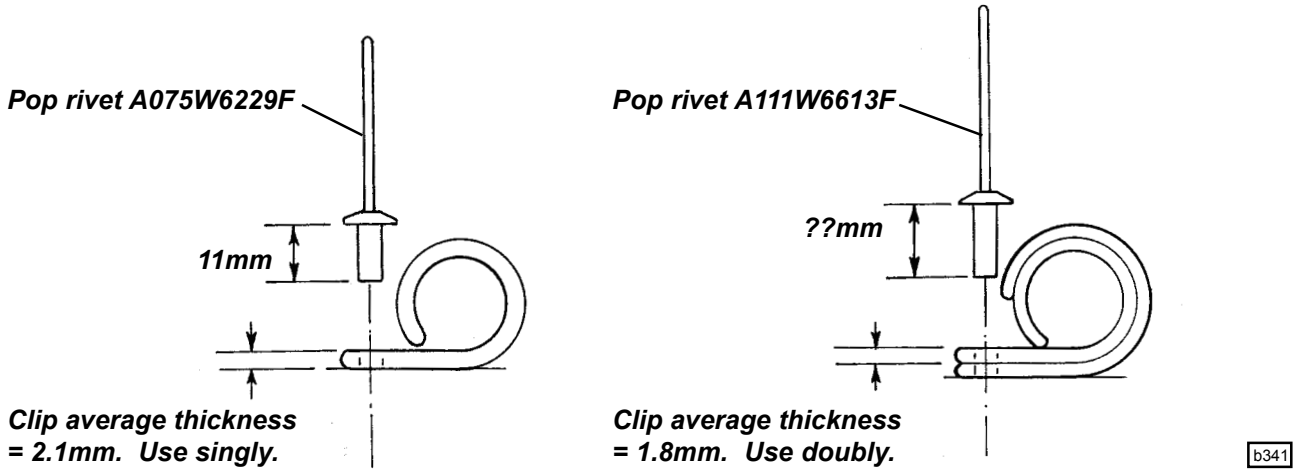
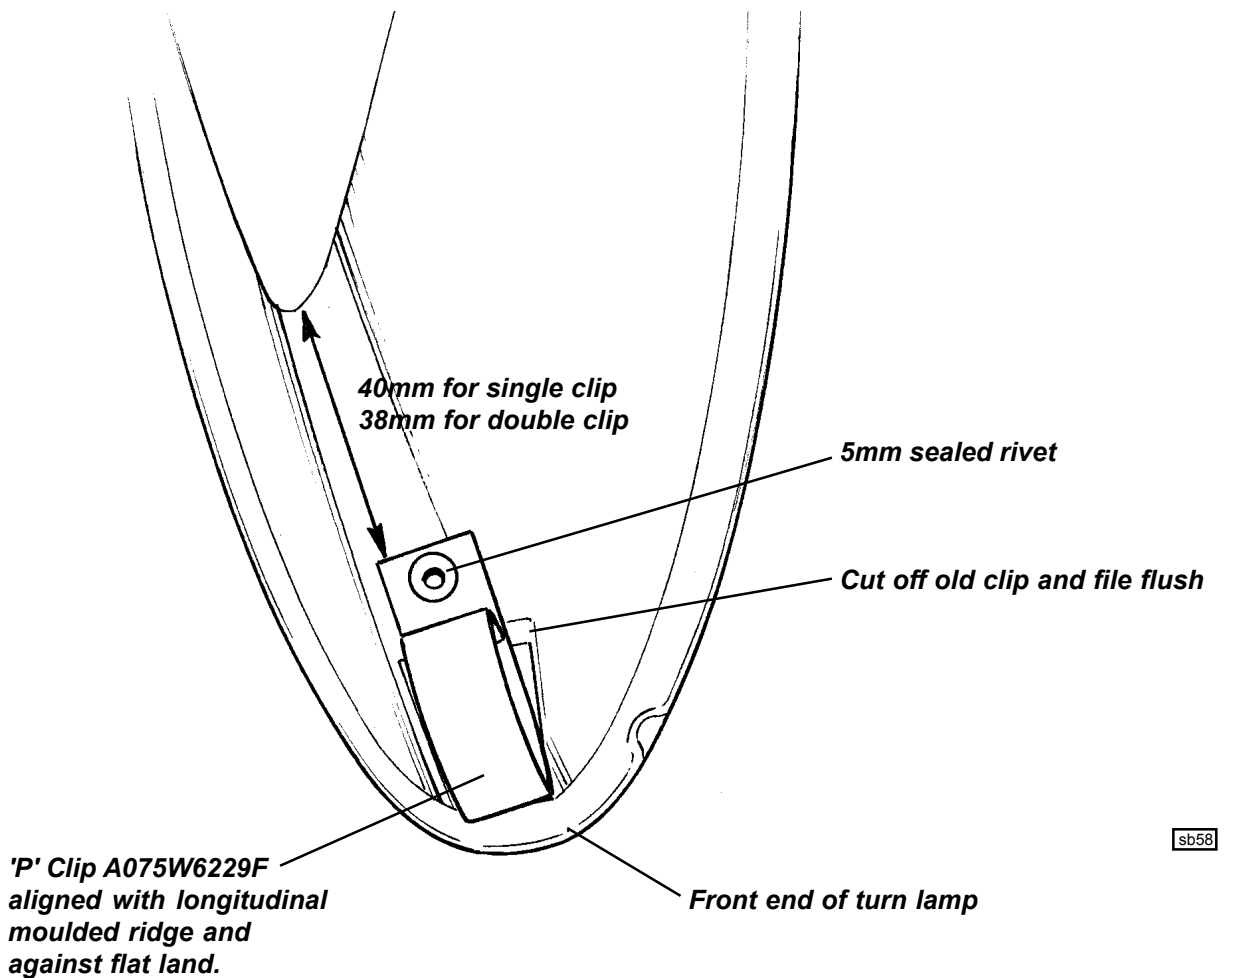
3. Cut off the lower moulded clip and file flat to the lamp body. Acquire 'P' clip A075W6229F and establish the variant by referring to the diagram below. Thick type clips are used singly with a short reach (11mm) rivet, whereas thinner type clips are used doubly with a long reach (??mm) rivet. Different hole positions are also used in each case.

4. Hold the new 'P' clip against the small flat land on the lamp body, with the end of the clip positioned as shown in the diagram, mark up the fixing hole position on the lamp, and drill to 5mm diameter. Secure the clip or double clip with the appropriate sealed 5mm rivet.
